Implementation – Post-Trip Plan

Executive Summary	
Community:	Ait Bayoud
Country:	Morocco
Chapter:	Columbia University
Submittal Date:	10/26/2019
Authors:	Raayan Mohtashemi, Alice Wu, Leanne Pichay, John Yatsko, Justin Paik, Gabriel McCormick, Rachel Ballew
REIC and other mentors:	Colin Barrett (REIC), Robert Prager (Geotechnical Engineer), Greg Scoby (Piping Engineer), Andrew Wedgner (Piping Engineer), Camille Rubeiz (Piping Engineer), Santiago Arnalich (Piping Engineer), Michael Conaboy (Civil Engineer), Sean Reischel (Civil Engineer), Ethan Cotton (Civil Engineer)
Scope of Work for the project (50 words) ¹	Design and implement a water distribution system for two villages in rural Ait Bayoud, Morocco. The project includes a well, solar powered water pump, high density polyethylene (HDPE) pipeline, and water storage system.
Scope of Work for the trip (100 words) ²	In this trip, we constructed a 38,000 L reinforced concrete storage tank, two water distribution sites, and a solar rack to hold 5.4 kW of solar panels. Additionally, we laid down 4 km of HDPE piping to connect the well site to the storage tank and the two distribution sites in Ilguilouda, and we installed a solar inver

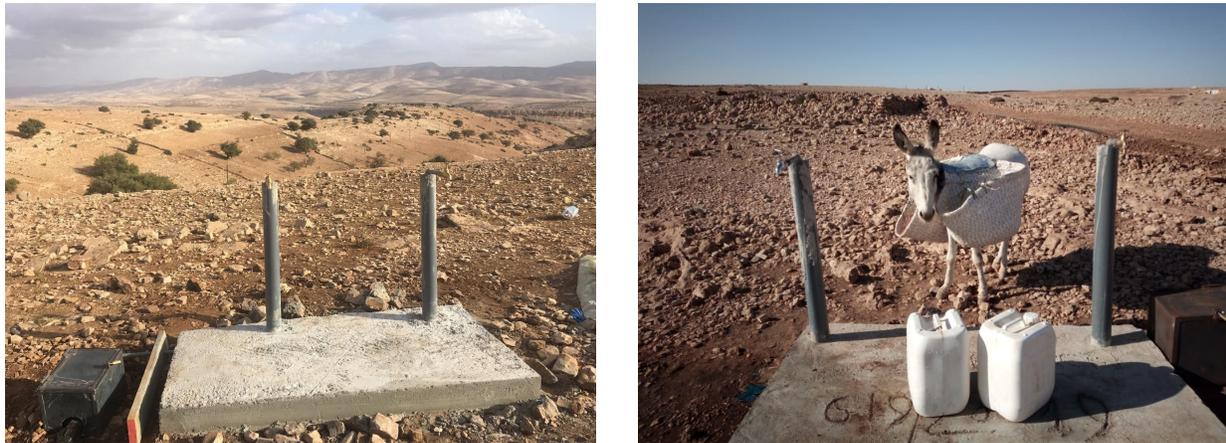
Figure 2. Domestic tap stand (left) and livestock tap stand (right)

We constructed two tap stands at Ilguilouda—one domestic tap stand and one tap stand dedicated to livestock water. The domestic tap stand includes a slab with a minor slope on which two taps are fixed. The slab at the livestock tap stand was constructed by the community after we left, and as a result we believe, with reasonable certainty, that it was poured flat.

The piping in the spigots is 20mm galvanized steel, a more rigid material compared to the HDPE piping used for the distribution system. Since these pipes would be more susceptible to weathering, erosion, and possible damage from misuse, the team selected 20mm galvanized steel to protect system functionality. Each tap stand includes a check valve and a gate valve to manage the flow of water. Additionally, each valve will be accessible through a valve box, in order to ensure that they are protected from potential tampering that could interfere with the functioning of the system. To protect the upright pipes of the taps, each tap will be cast in concrete, using a 90mm PVC pipe of the same height as a mold.

A tap stand for domestic use was connected to the end of the main pipeline. In the future, the connection will be changed such that domestic tap stand branches off from the main pipeline through a tee. This way, the main pipeline can continue on to Izgouaren. A tap stand for livestock use was constructed next to the mosque in Ilguilouda and branches off from the main pipeline through a tee.

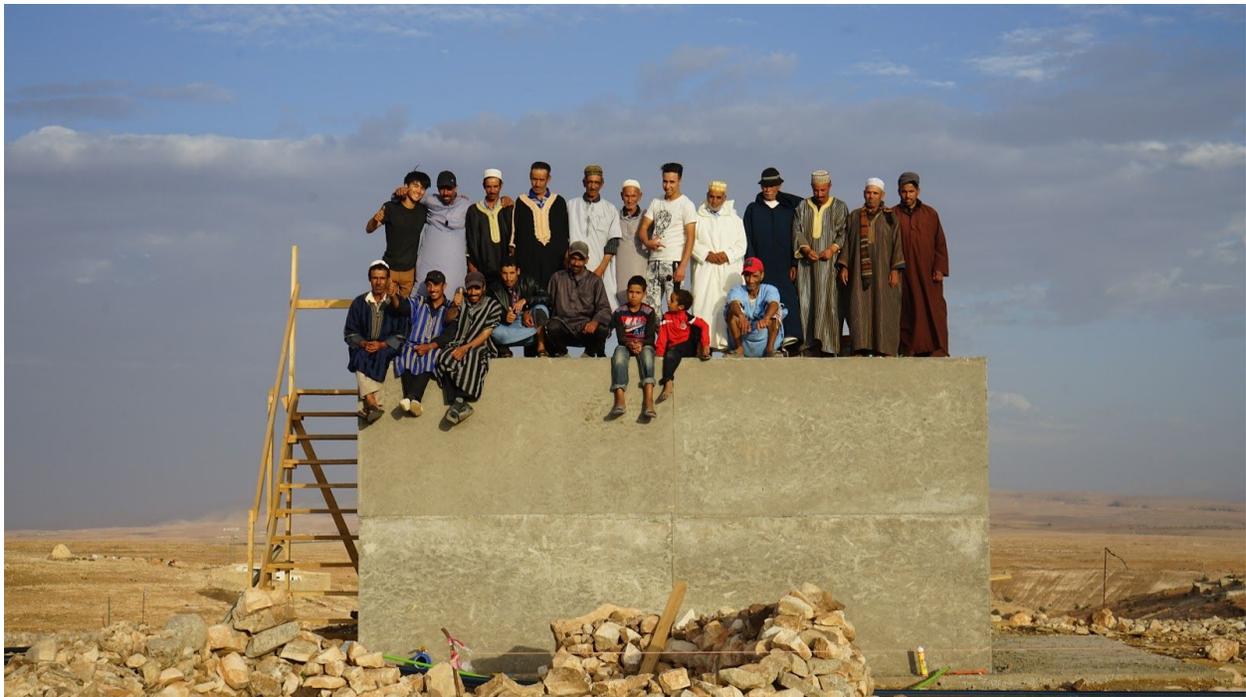
We constructed a reinforced concrete water storage tank on the reinforced concrete slab previously constructed by the EWB-CU Chapter. The tank has 38,000 liters of water storage capacity, consisting of two chambers: a settling chamber with a volume of 14,000 liters, and a storage chamber with a volume of 24,000 liters. The tank is in Iguilouda at the highest elevation point between the pump and the tap stands. It stores enough water for two cloudy days and provides a minimum detention time of three hours for particle settling. See Attachment A for updated drawings

Figure 3: The finished storage tank with community members from Izgouaren.

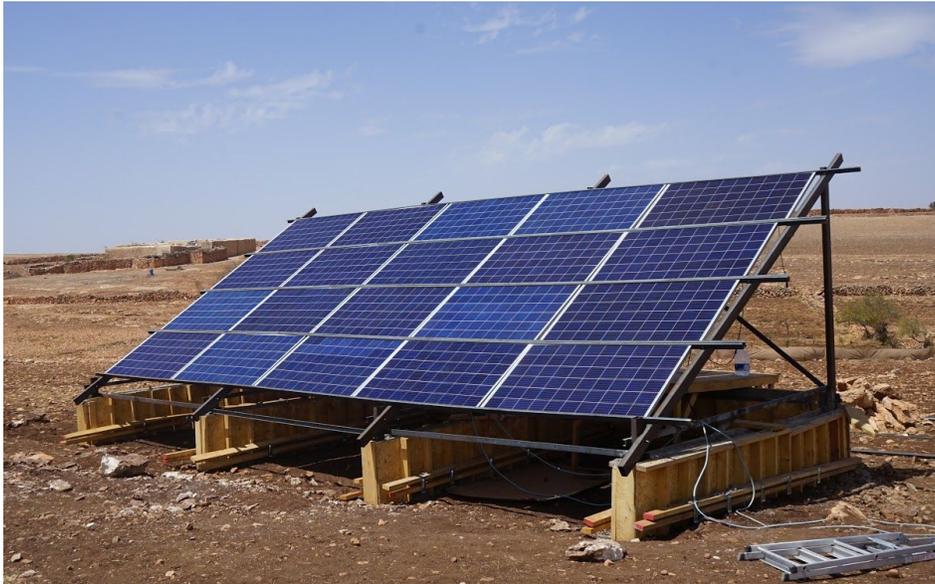
The solar panels were mounted on a large steel rack, cast into a reinforced concrete foundation. This structure was built to hold the solar panels at a tilt of 31 degrees from the horizontal. The dimensions of each solar panel are 1640 mm x 992 mm x 35 mm. The width of the structure is 4 meters, the length is 9 meters, and the height at the high end is 3 meters. The rack has four 9m long slots in which strings of 5 panels were inserted. Each panel was fastened to the steel rack by four screws at the corners.

The structure is composed of 50mm x 100mm x 9mm thick rectangular tubing, 75 mm x 75 mm x 6mm thick W members, and 75 mm x 35mm x 6mm thick C members. The W members formed 18m long slots for the panels and were bolted to the rectangular tubing, instead of welded as was originally planned. The rectangular tubing and C members were bolted together to form trusses. The legs of the tack were embedded in concrete.

Figure 5. Picture of the front of the completed solar panel structure. The formwork for the concrete had not yet been removed in this picture.

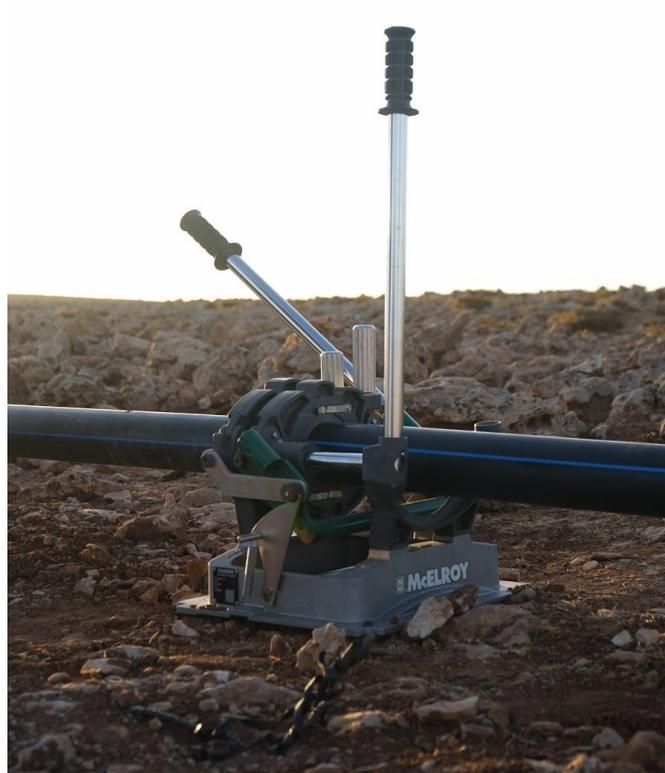
Up to ten joints could be done per day with the McElroy PITBULL 14. Following ASTM F2620-13 procedures, 90mm DR 11 pipe was installed. Heat soak time was 1:26 while fuse/cool time was 3:32. Temperature of the heating plate was 425 F. After fuse/cool time, the pipe was let to sit in the machine for 15 minutes without disturbance as recommended by our mentor Rob Lawrence. Donald led the process for the first couple days, until thereafter, he switched to the role of directing and advising the installation. The locals quickly picked up the procedure and upwards of ten locals are knowledgeable in fusion procedures. Most days, only four to six joints were done due to other interruptions.

Figure 7. Picture of the set-up for butt-fusing pipes.

Usually three to four locals would set the pipe into the holdings of the machine. Pulling 100 meters of 90mm DR 11 pipe can be strenuous. The pipe was installed such that each side of the pipe end came in to create an S shape, horizontal to the ground. An S-shape insured pipes would be square to each other. While waiting for the heating element or cool time, locals and Donald would clean the path free of rocks and point loading. We used shovels and pickaxes to do this work. After fusion, we would place the pipe into the pipe path created for the pipe.

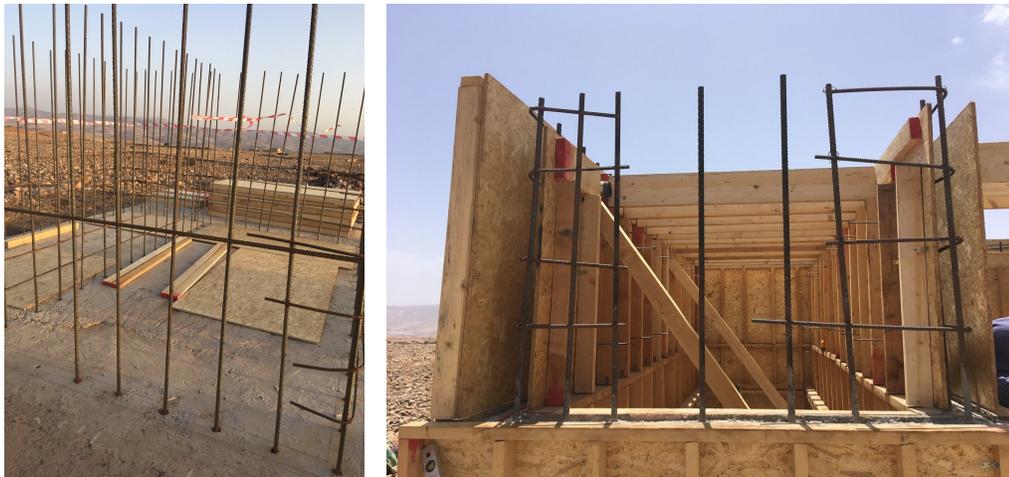
Next, the exact dimensions of the tank were marked on the concrete slab that sits underneath the tank using a marker, for the purpose of helping to ensure proper alignment of wooden formwork and iron rebar. Then, holes were drilled 22" apart, center to center, and vertical iron rebar placed into those holes. Horizontal iron rebar was also placed on the outside of the vertical rebar to create a grid-like pattern in a way that still

Figure 8. Left: Rebar cage. Right: Close-up of formwork being assembled around rebar.

After the rebar for the walls was secured in place, the wooden frames for the lower half of the walls of the tank were constructed. These frames included a large piece of plywood facing the area where the concrete would eventually be poured, as well as studs placed on their strong axis attached to the plywood for support. These studs were constructed from wooden pieces measuring 40 cm x 80 cm. After the frames secured and the corners attached, the snap ties were secured in place, with their precise locations measured out beforehand, and drilled to create a hole for them. Next the wales were constructed along the snap ties on their strong axis to provide additional support for the frames, and finally the snap tie wedges were drilled into place. During the process, the proper pipes—inflow, outflow, overflow, etc.—were also installed into the formwork.

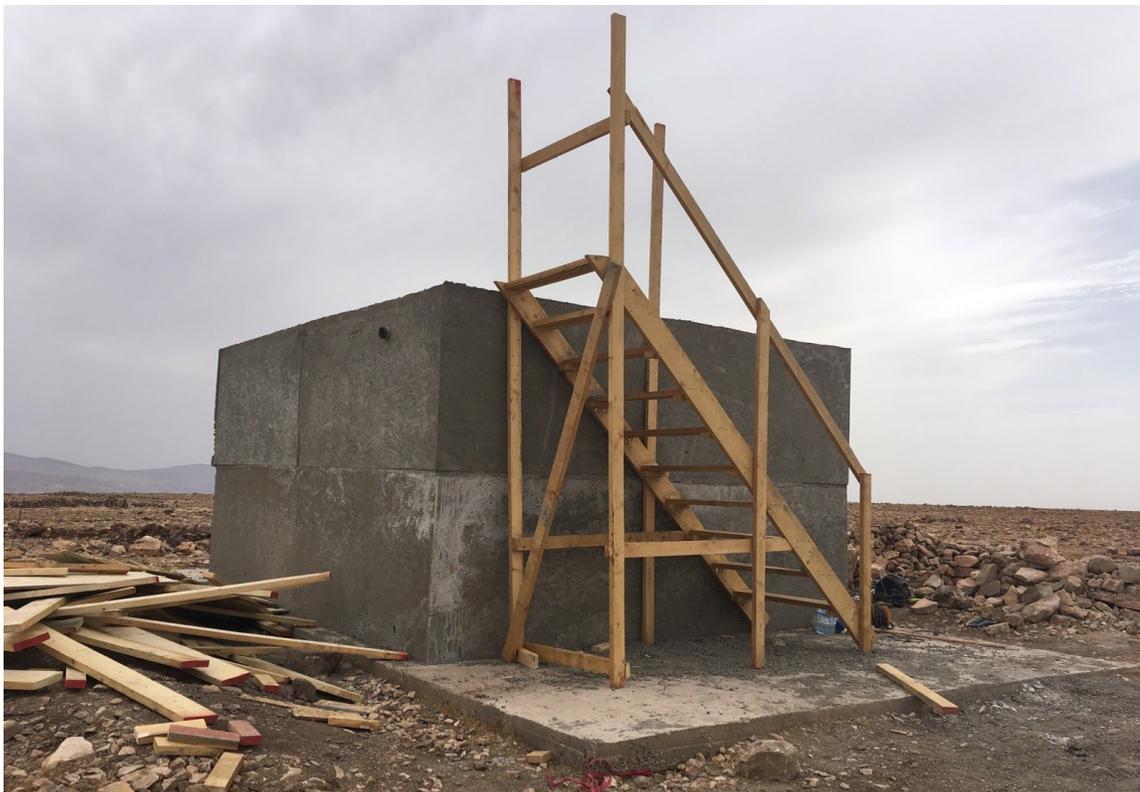
At this point, we were ready to pour the upper walls and the lid in one continuous pour. After the pour, the concrete was again watered and covered with blankets for four days. After the concrete had been given enough time to solidify, the wooden forms for the concrete were disassembled, both inside and outside, and the snap ties were snapped off. The inside of both chambers of the tank were swept with a broom and dust pan, and a water sealant was applied to the edges of where the walls met the concrete slab.

Figure 10. This picture shows the completed tank. The stairs in front of the tank were built to use during the construction.

Due to leaks at the bottom of the storage tank caused by honeycombing, after the team left, the community poured a new layer of concrete on the floor of the tank to cover the leaks.

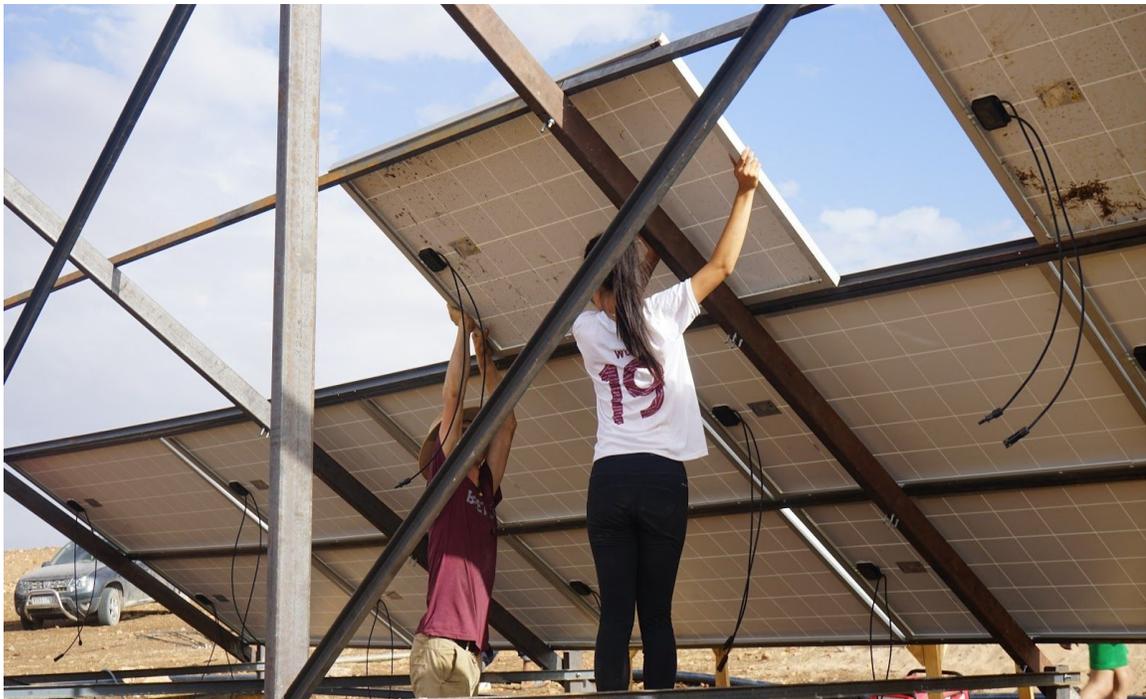
Construction on the solar panel structure began on August 20th. Justin led the construction of the formwork for the concrete base to hold down the solar rack and the rest of the team assisted as they were available. Meanwhile, John led the construction of the metal structure with assistance mainly from Anwar, Zineb, Meriem and Alice. On Thursday, August 22nd, John and Anwar made a trip to Marrakech to purchase a metal drill to drill holes in for the bolts, so construction paused for one day. The team worked through the weekend of August 24th to 25th. The concrete footing was poured on Wednesday, August 28th. From August 29th to 30th, the c channels for the metal structure were bolted down while simultaneously installing and bolting down the solar panels.

Figure 11. Picture of the process of installing solar panels. Solar panels and c channels were installed simultaneously from the bottom to the top of the solar rack. The top c channel had to be lifted in order for each solar panel to slot into place between the two c channels. Then, once the solar panels are in place, the top c channel would be bolted down and the solar panels would be bolted to the c channels at the four corners.
